**DREDGING OPERATIONS TECHNICAL  
SUPPORT PROGRAM**

TECHNICAL REPORT D-90-13

**GUIDELINES FOR VEGETATIVE EROSION  
CONTROL ON WAVE-IMPACTED COASTAL  
DREDGED MATERIAL SITES**

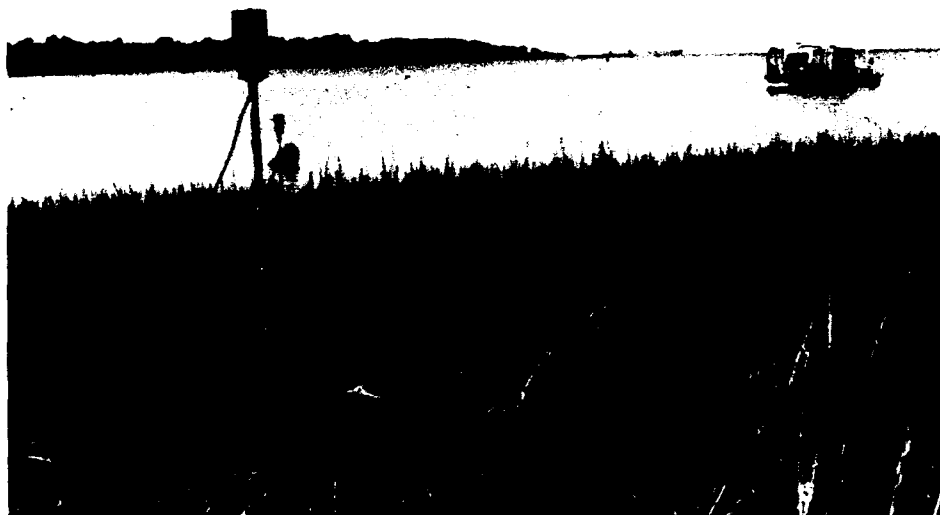
Figure 3. Measuring wave dissipation in smooth cordgrass marsh, Chesapeake Bay, Virginia (from Knutson, Seelig, and Inskeep 1982).

has traveled. Of importance is that more than 50 percent of the energy associated with these waves dissipated within the first 2.5 m of the marsh and that virtually no wave energy persisted at the 30-m distance for the conditions evaluated.

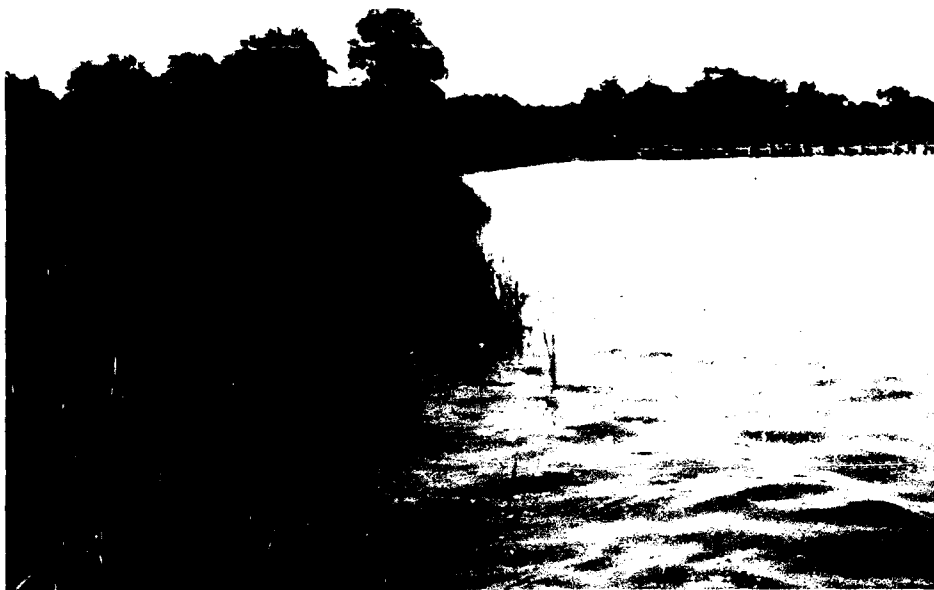
Figure 6. Appearance of natural shoreline,  
planted in 1934, Cherrystone Inlet,  
Virginia (from Knutson et al. 1981)

21. Marshes are a visual transition between land and water, and a natural feature of the landscape. They add form, color, and texture to the shoreline. Unlike other forms of shore protection, marsh plants, once established, provide no visible evidence that there has been a human effort to reduce erosion, as illustrated in Figure 6.

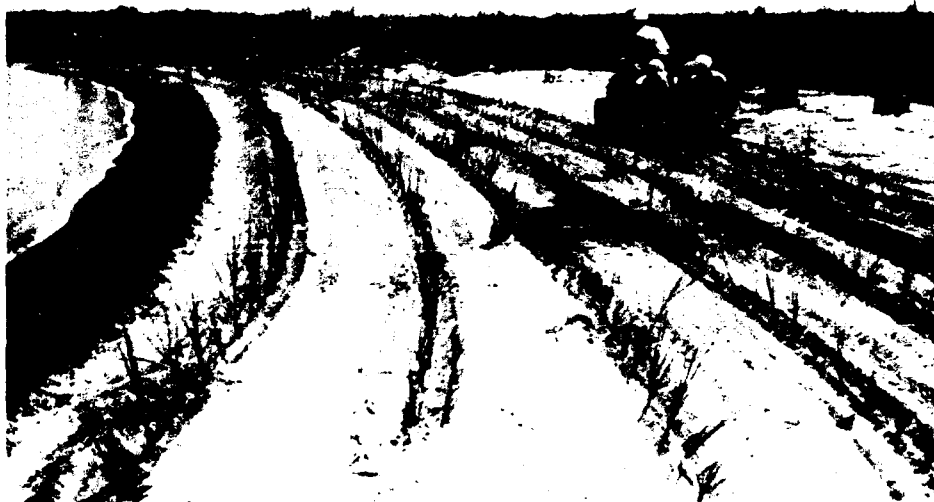
Figure 7. Mechanical planting with disk-  
type tobacco planter

planters designed to transplant crop plants such as cabbage, tomatoes, and tobacco are available in most regions. Although some may require an alteration of the row opener for certain soils, they can often be used without alteration. The principal barriers to machine planting are usually inadequate traction on compact and slippery substrates, insufficient bearing capacity on soft sites, or the presence of tree roots or stones that interfere with the functioning of the row opener.

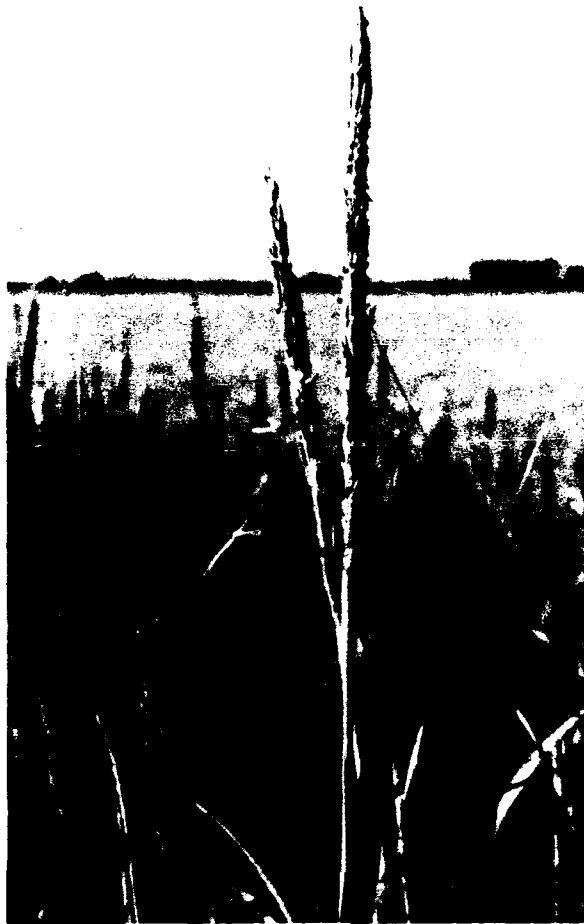
a. Seed head (inflorescence)

Figure 13. Pacific cordgrass (*Spartina foliosa*)

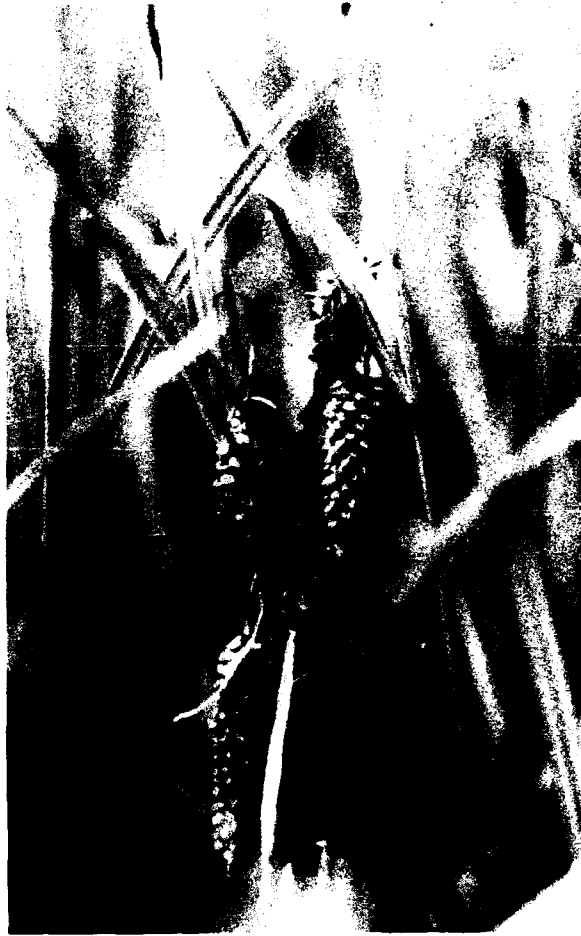
a. Seed head (inflorescence)

Figure 14. Lyngbye's sedge (*Carex lyngbyei*)

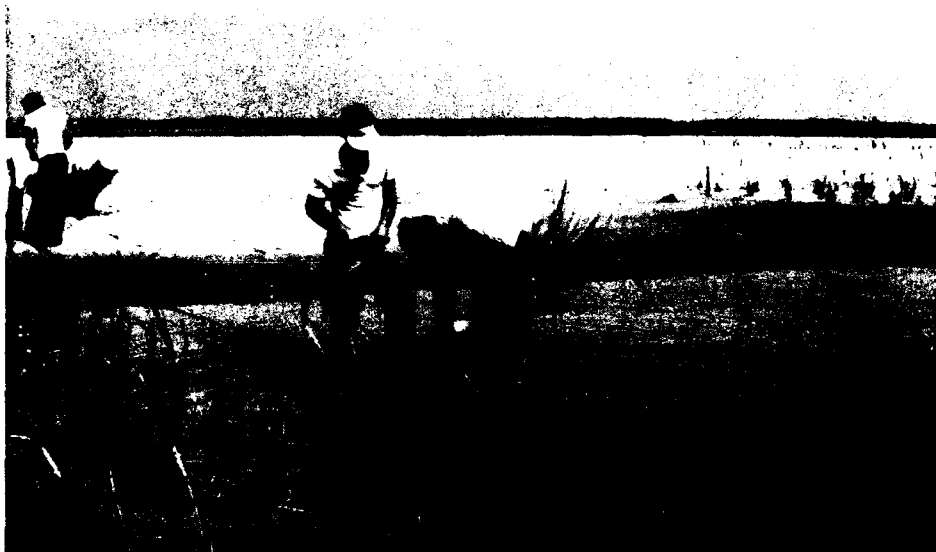
Figure 16. Hand-planting sprigs (photo courtesy of W. W. Woodhouse, Jr., E. D. Seneca, and S. W. Broome, North Carolina State University at Raleigh)

52. Hand planting can be very satisfactory if adequate attention is given to details, particularly planting depth and soil firming after planting; this is usually the most practical method for small-scale plantings. Opening of planting holes is readily done with dibbles, spades, and shovels in loose, sandy soils. Portable power-driven augers work well in the more difficult cohesive or compact soils. Normally, planting crews work in pairs, one worker opening holes and the other inserting the plant and closing the hole. A third worker is used if fertilizer is added in the planting hole; this worker drops in a measured amount of material just after the hole is opened and before the plant is inserted.

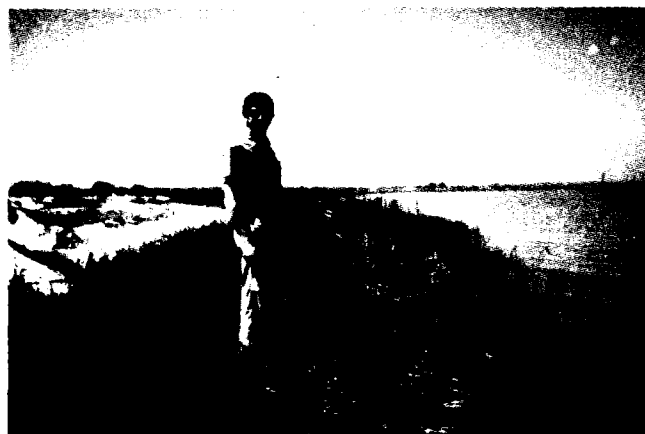
Figure 20. Coffee Island marsh development site

a. Photo taken 3 months after planting  
(note plant rolls seaward of single-  
stemmed plants)

b. Photo taken after 18 months after  
planting

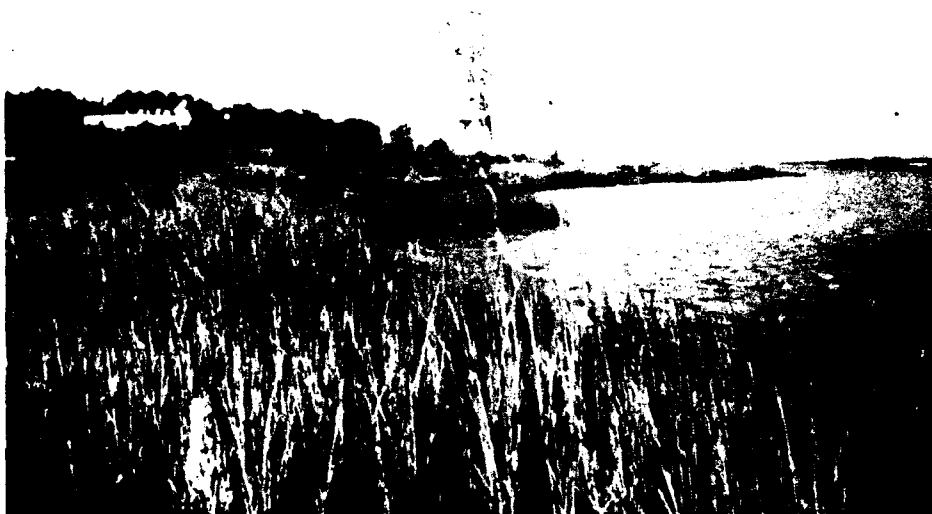
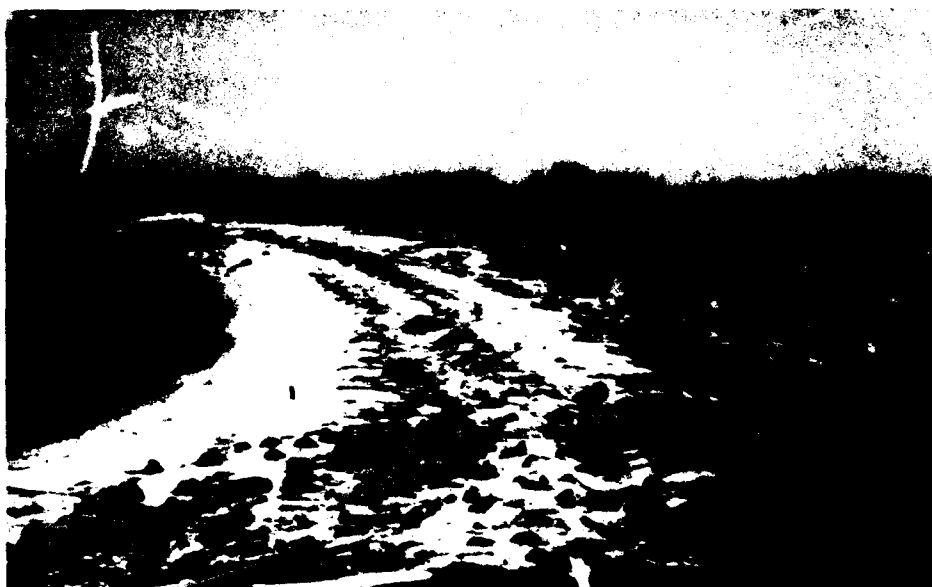
Figure 21. Erosion control planting site at Cedar Island,  
North Carolina

a. Photo taken 17 months after  
planting

b. Photo taken 8 years after  
planting (note absence of  
planting)

73. Knutson et al. (1981) describe a planting at Cedar Island, North Carolina, that was fully established after 2 years (Figure 21a) but completely eroded after 8 years (Figure 21b). This was a high-energy site (average fetch = 20 km). One should anticipate that after a breakwater ceases to function, erosion will begin to degrade the seaward edge of the marsh. The greater the wave energy at the site, the shorter will be the effective life (design life) of the vegetative stabilization effort. For shallow water (about 3.0 m deep), a practical average fetch-length limit for vegetative stabilization projects (even when temporary wave protection is provided) might

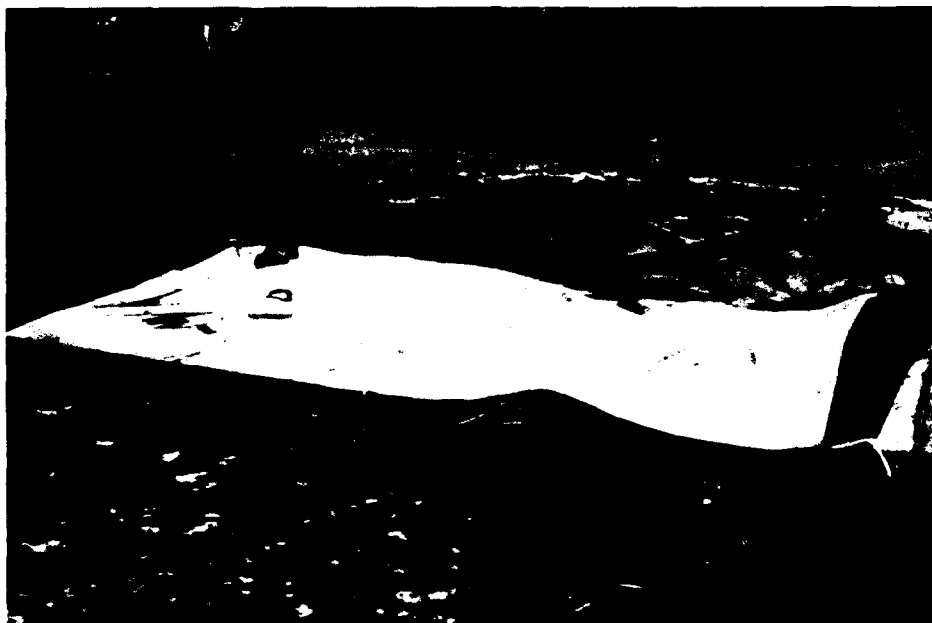
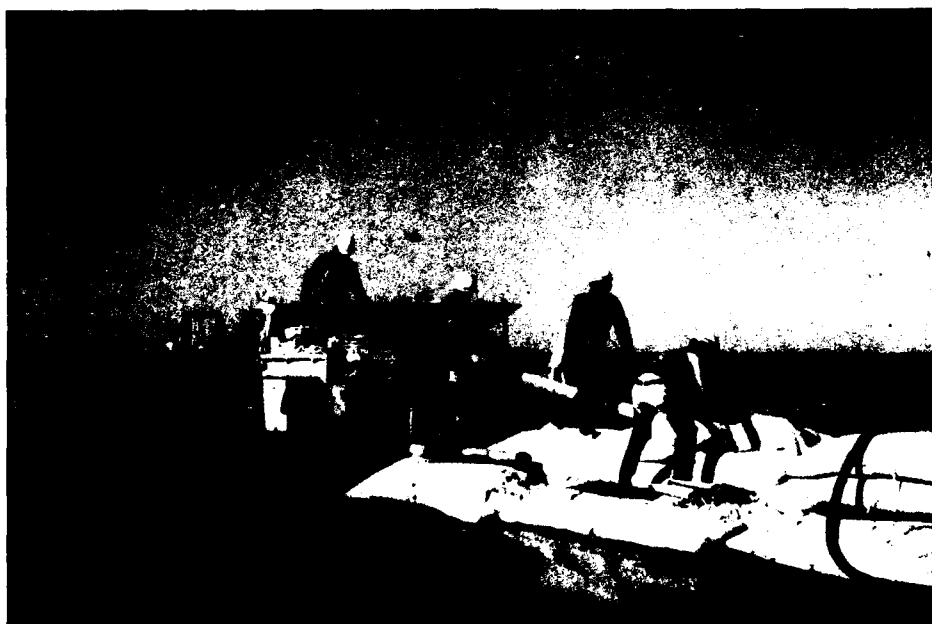
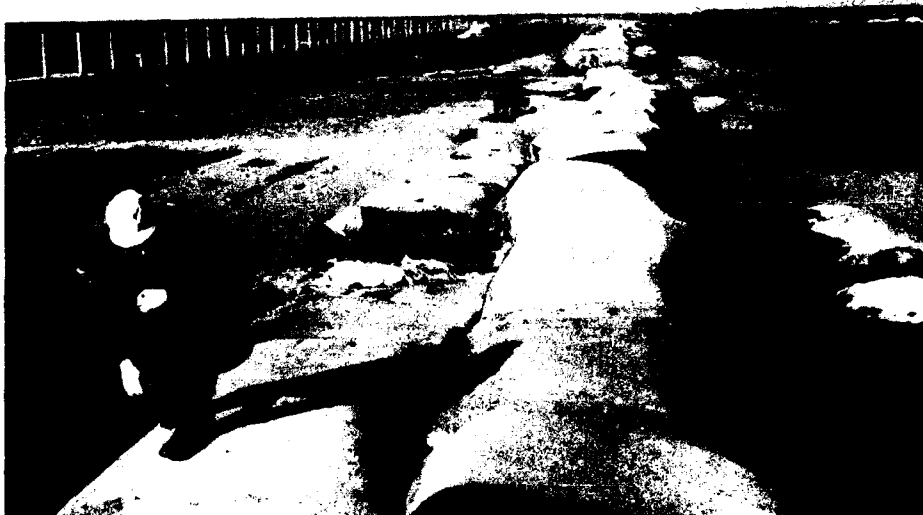
Figure 23. Construction of sandbag breakwater (Continued)

a. Empty cloth bags placed  
on filter cloth

b. Bags filled with a sand  
slurry in-place

c. Newly completed dike

d. Dike after exposure to the elements for  
2 years

74. Any container filled with sand, sand-cement, or concrete that is used as building block material for a breakwater will be considered a sandbag breakwater for purposes of this discussion. In construction projects, nylon fabric bags are typically used because of their durability. Sandbag breakwater life expectancy is 2 to 5 years, depending upon site accessibility to humans and subsequent vandalism, exposure to sunlight (ultraviolet rays degrade fabric), and energy forces exerted against the dike. Bags can be filled onsite with hydraulic pumps (sand/water slurry) until inflated and then sealed. Bag breakwaters must be underlain with filter cloth to prevent scour and resultant subsidence of the structure. While intact, sandbag breakwaters provide nearly total protection from wave attack. One consequence of this protection is that sediment deposition may initially be quite high in the protected area. To avoid burial of the new plantings, the planting operation should be delayed several weeks until a measure of stability has been achieved.

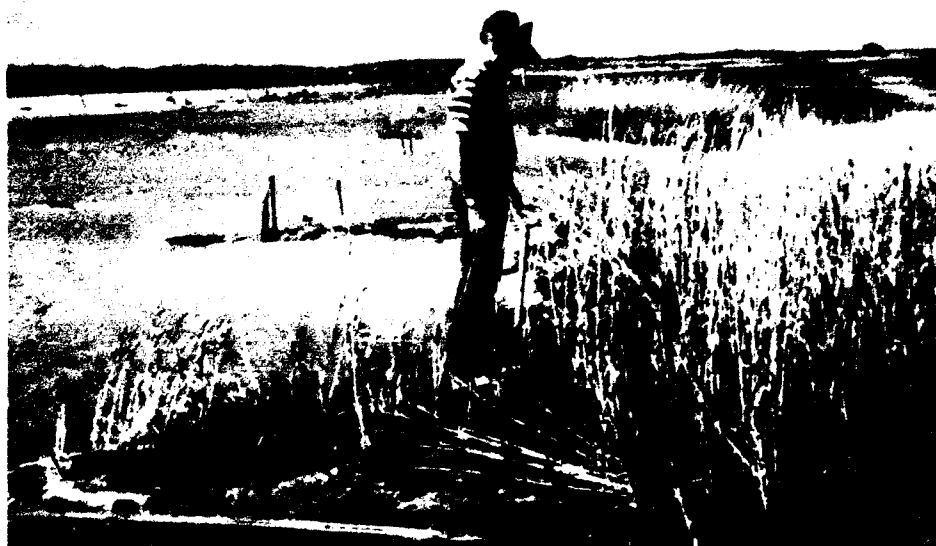
Figure B6. Erosion control mat plot in November 1985, about 1.5 years after planting

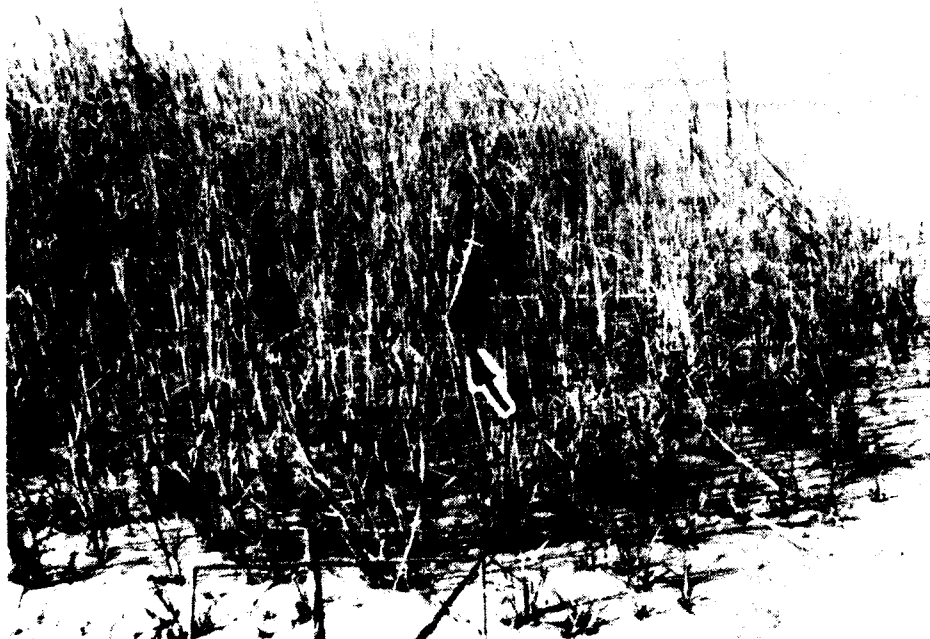
Figure B8. Plant spread in a mat plot as observed in November 1986, about 2.5 years after planting (tape shows edge of original plot)
